Rental Requirements Inspection

RACV Property Inspections

Property Address: 123 Safer Home St, Melbourne, Victoria 3000

Date: 3rd November 2021

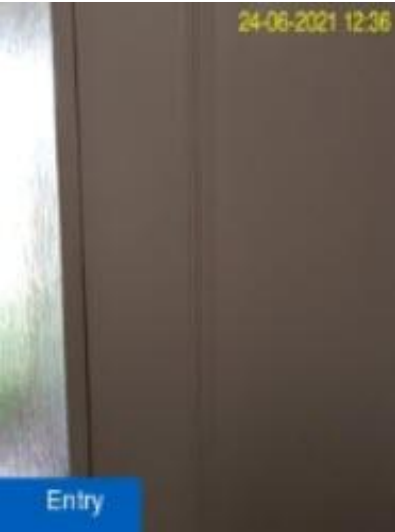
Entry	Standard Not Met	Visual inspection revealed external lock concerns due to a single action deadlock not functional on external entry door.
-------	-------------------------	--

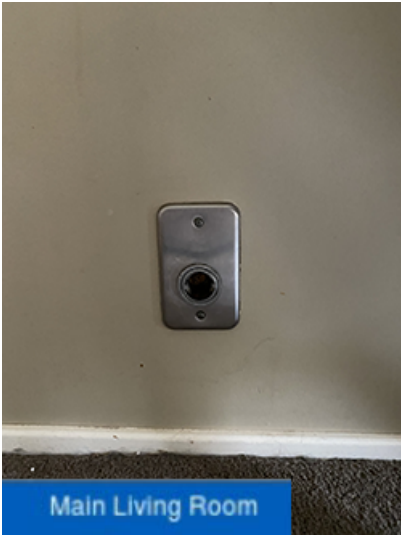
Visual inspection of the main living area revealed evidence of concerns regarding heating due to: no fixed heater installed.

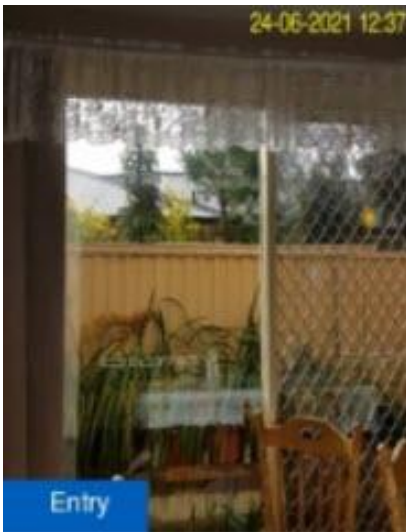
Entry	Standard Not Met	Visual inspection of all internal windows in habitable areas revealed concerns due to a fitted window covering cannot be opened or closed.
-------	-------------------------	--

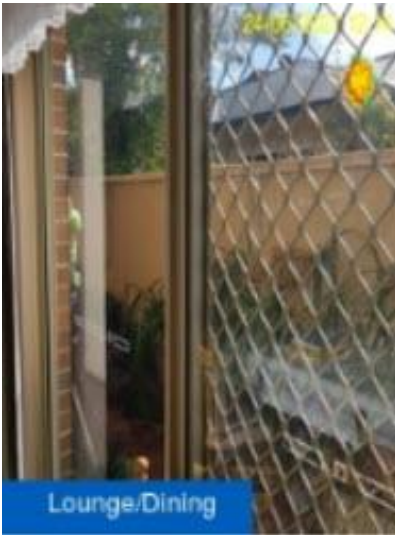
Lounge/Dining	Standard Not Met	Visual inspection of all internal windows in habitable areas revealed concerns due to no curtain or blind is present.
---------------	-------------------------	---

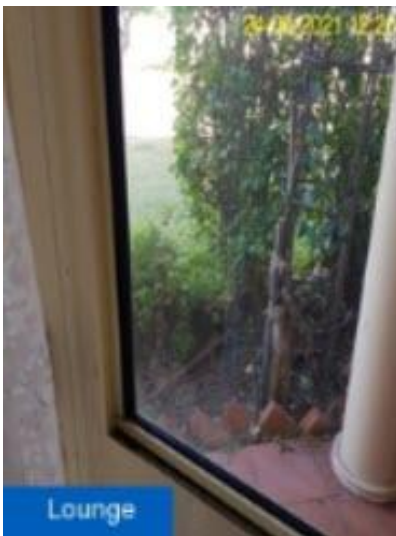
Location	Result	Statement
Lounge	Standard Not Met	Visual inspection of all external windows revealed concerns due to a window not able to be set in open or closed position and a window latch does not exist.

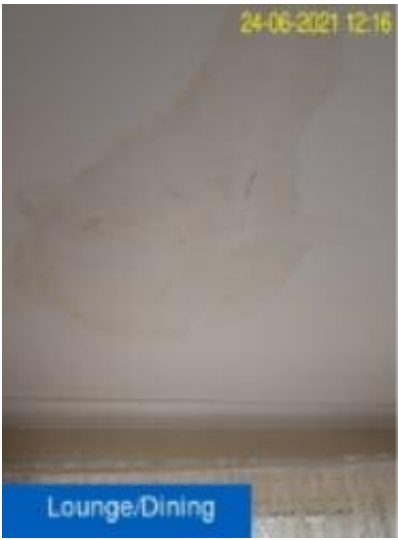
Location	Result	Statement
Lounge/Dining	Standard Not Met	Visual inspection of each room revealed evidence of concerns due to evidence of mould present in room.

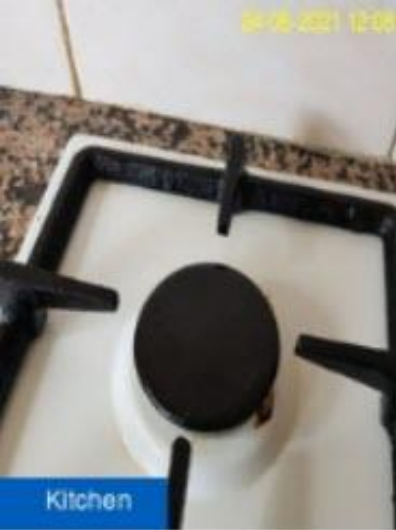
Kitchen	Standard Not Met	Visual inspection of accessible areas as per scope revealed evidence of concerns regarding kitchen facilities due to an inadequate number of stovetop burners.
---------	------------------	--

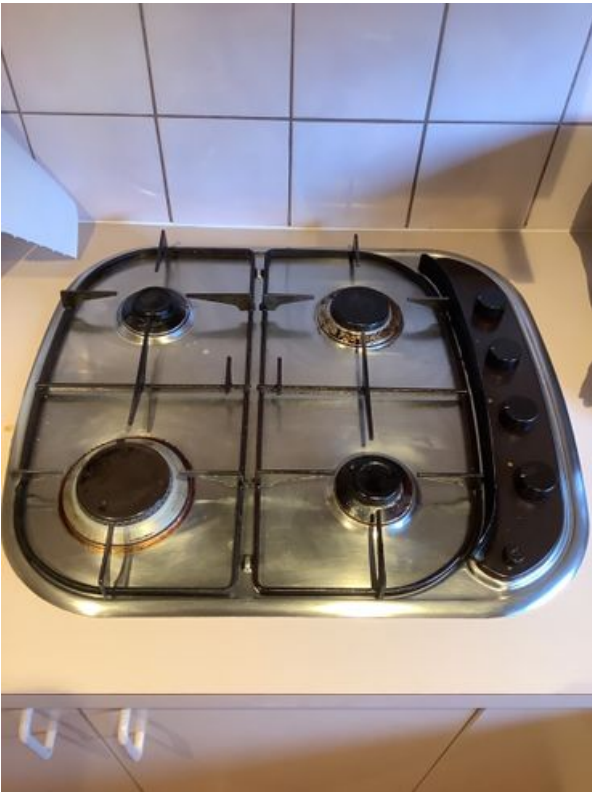
Photo 1

Kitchen 4x gas burner cook top. No make or model visible.

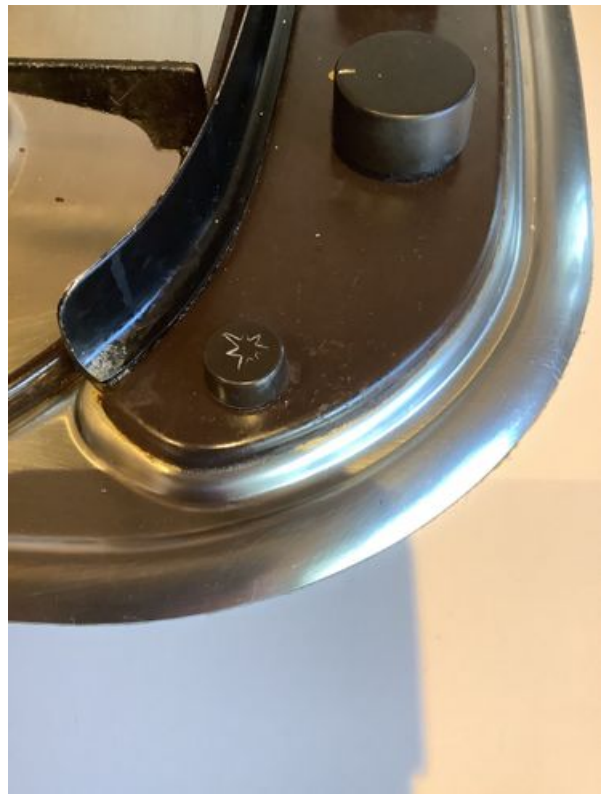
Photo 8

Ignition button faulty and no signage at 4x gas control knobs to identify correct burner.

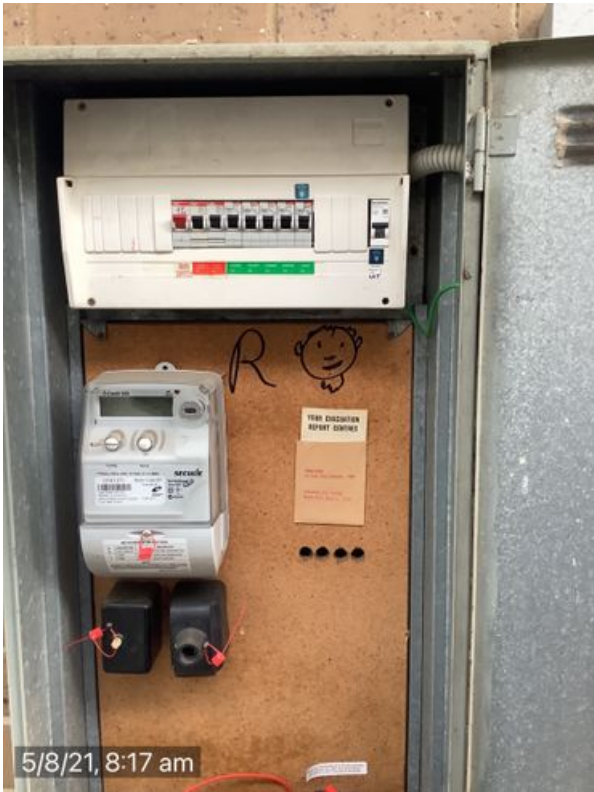
Photo 1	
Exposed Earth Electrode	Verified by Visual Inspection
Metallic Water Pipe Bond	Verified by Visual Inspection
RCDs (Safety Switches)	Verified by Visual Inspection
Circuit Protection (Circuit Breakers/Fuses)	Verified by Visual Inspection
Socket-Outlets	Verified by Visual Inspection
Light Fittings	Verified by Visual Inspection
Broken kitchen track light not connected but broken removed and cable put in junction box for safety

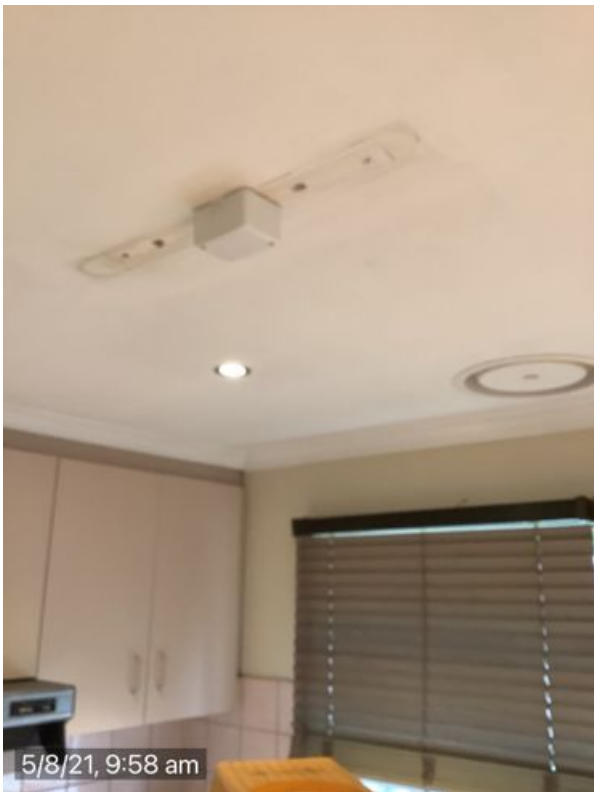
Photo 3	
Electric Water Heater	Not Applicable
Air Conditioners	Verified by Visual Inspection
Evap Cooler on roof	
Space Heaters	Not Applicable
Cooking Equipment	Verified by Visual Inspection
Dishwasher	Verified by Visual Inspection
Exhaust Fans	Verified by Visual Inspection
Ceiling Fans	Verified by Visual Inspection
Washing Machine/Dryer	Verified by Visual Inspection
